CASE REPORT

# Two stage fracture of a polyethylene post in a 9-year-old posterior-stabilized knee prosthesis: a case report

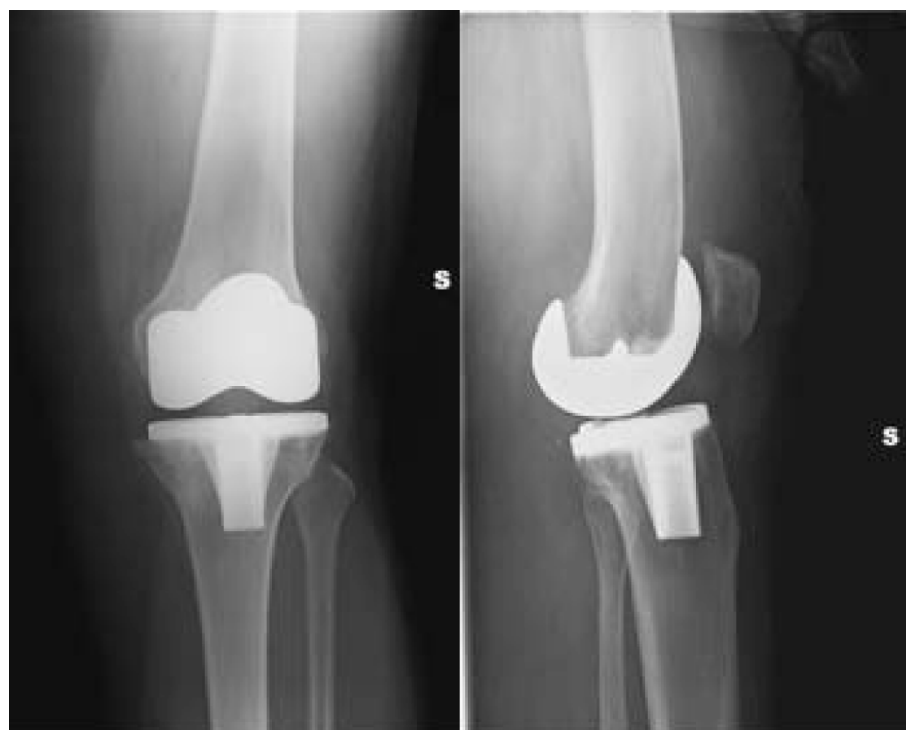
acute event she was unable to bear weight on her left knee, and was thus forced to use crutches. On physical examination she presented a mild effusion of the knee, a flexion of 90°, and knee hyperextension. The joint presented signs of both anteroposterior and varus to valgus instability. X-ray examinations showing the anteroposterior view of the knee did not indicate any remarkable alteration in polyethylene wear, while the lateral view showed a hyperextension of the tibia with a posterior subluxation of the femur (Figure 1). The hypothesis of post breakage was thus made.

**Figure 1 Preoperative X-rays.** The hyperextension of the tibia in relation to the posterior subluxation of the femur can be seen.

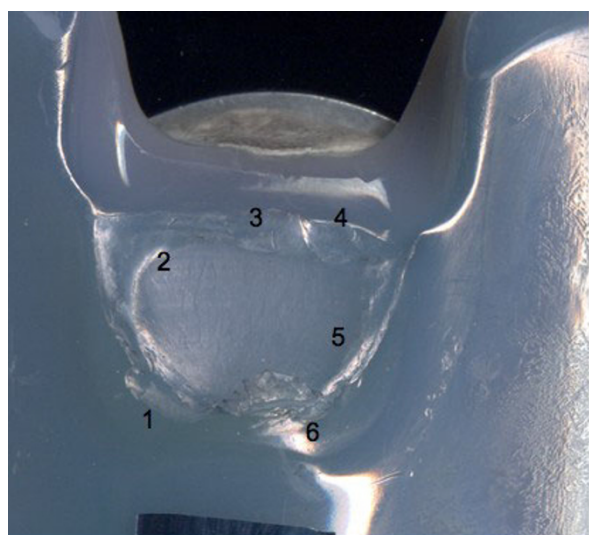
**Figure 2** Numerated areas of the polyethylene insert.

Scanning electron microscopy, as reported in the literature [14,18], is an effective modality for analyzing the surface of fatigue fractures. An evaluation of the retrieved tibial polyethylene insert via SEM revealed two different damage patterns, considering the medial part and the lateral aspect (Figure 4). The medial part (Figure 2 areas 1, 2 and 3, Figure 4, Figure 5, Figure 6) presented a fracture line laminated in front and smooth behind and with the tear lines with a mediolateral and anterior posterior orientation.

The total knee components appeared to be well fixed intraoperatively. The polyethylene insert was substituted

with a 12-mm CD LPS Flex articular surface (Zimmer, Warsaw, Indiana, USA). The stability in full extension, mid-flexion, and full flexion of the knee was tested intraoperatively, and appeared to be good. The patient had no postoperative complications and recovered well.

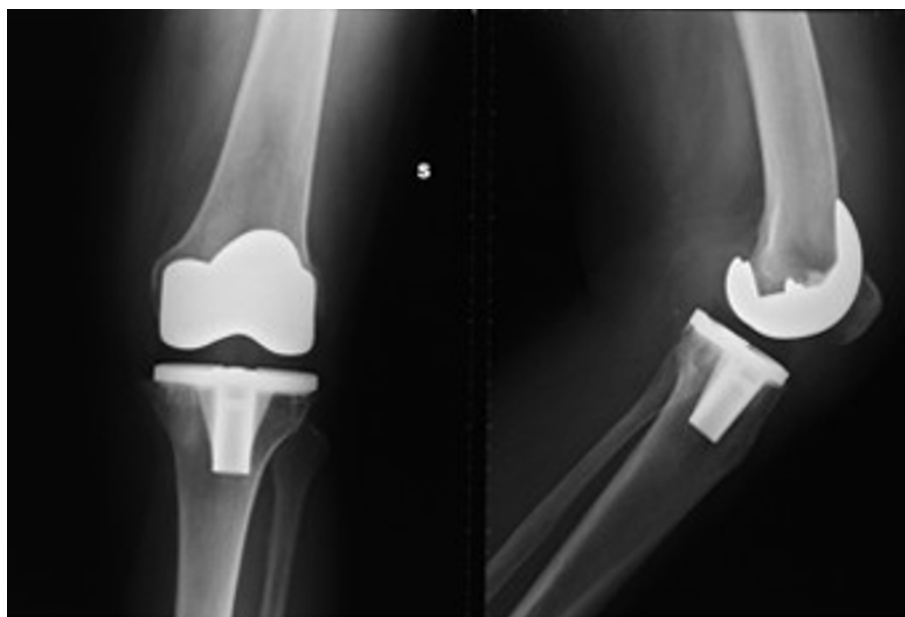
At six months follow-up the patient had recovered complete function of her left knee. She was free from pain and could walk normally without any support (Figure 3).

**Figure 3** X-rays at six months follow-up examination.

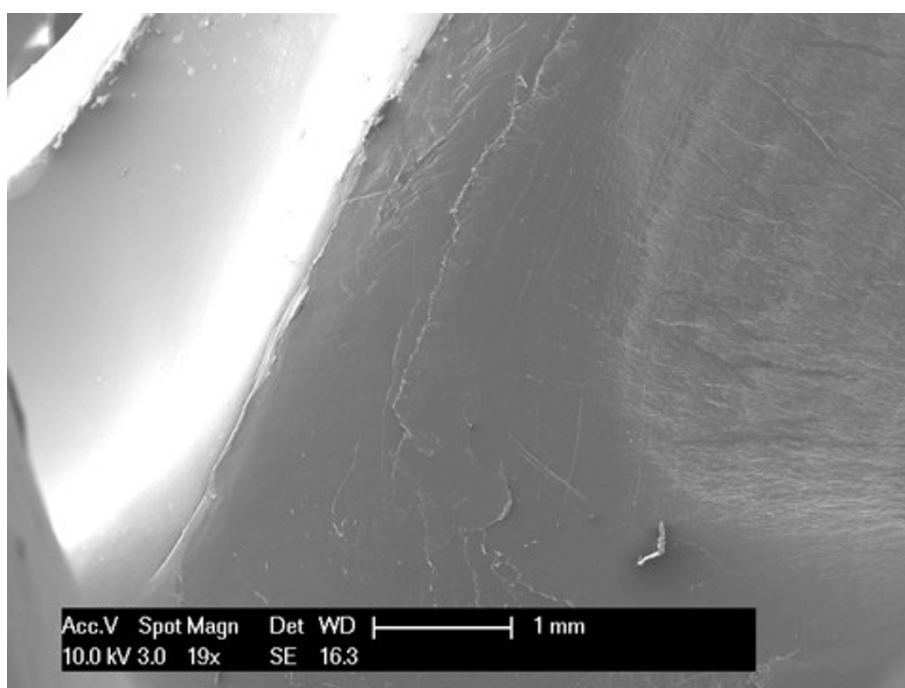
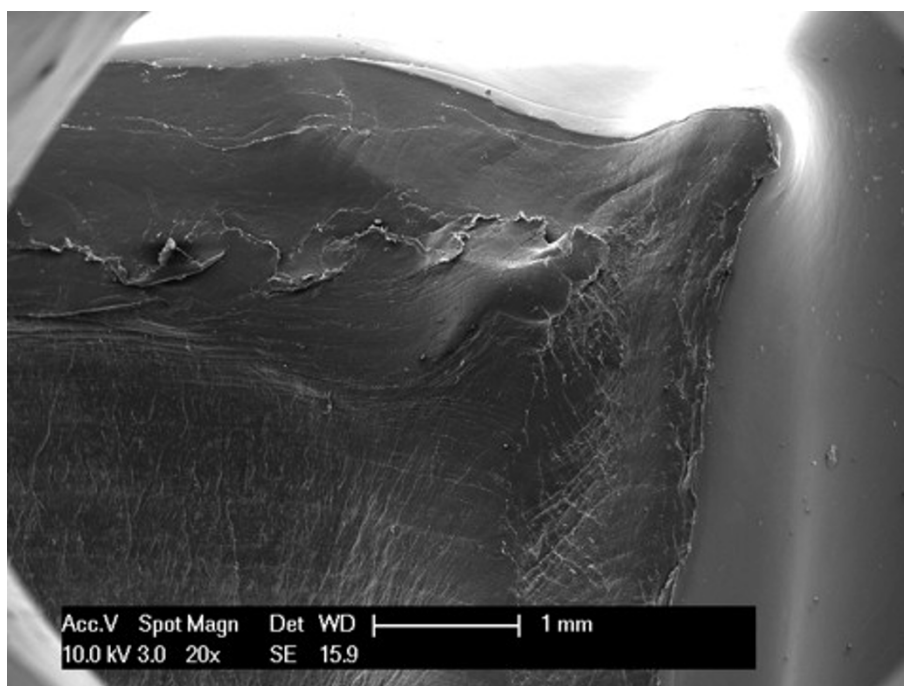
The medial part of the fracture edge appears to be smooth (Figure 2 areas 2 and 3) and with a different orientation of the fracture lines. These characteristics suggest a chronic instability of the varus valgus knee prosthesis that slowly weakened the polyethylene post.

**Figure 5** Area 2 of Figure 2.

**Figure 6** Area 3 of Figure 2.

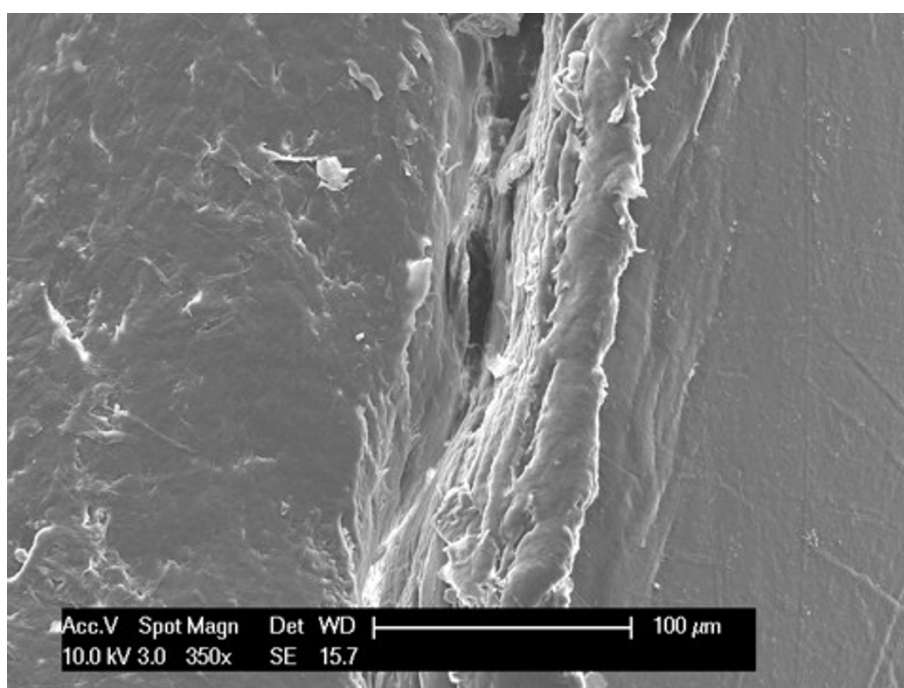
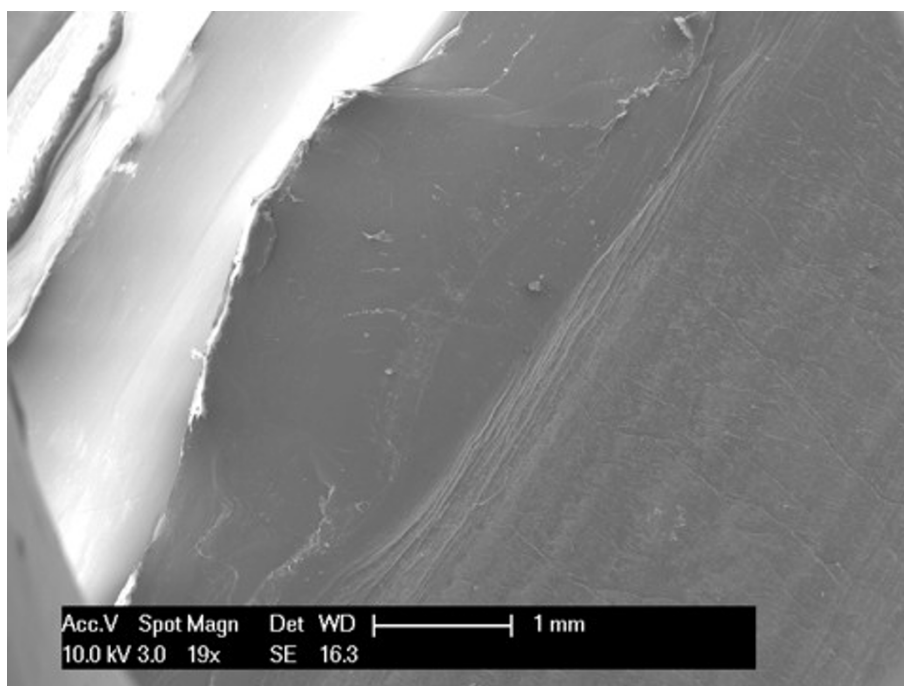
Meanwhile, the lateral part (Figure 2 areas 4, 5 and 6, Figure 7, Figure 8, Figure 9) of the fracture presented a sharp line that ends anteriorly with a laminated tear (Figure 2 area 6, Figure 9) parallel to the anterior edge of the polyethylene insert. This implies that this area could be the terminal acute failure area of the fractured post. The final rupture occurred after the chronic weakening of the polyethylene due to the mediolateral stress on the tibial post. These features could be explained with a two-stage rupture of the polyethylene post. First, a varus and anteroposterior force caused partial rupture and instability of the post, which caused progressive smoothing of the medial and posterior fracture edges. Consequently, an anteroposterior lift-off force led to the complete rupture of the post. This could have been

**Figure 7** Area 4 of Figure 2.

**Figure 8** Area 5 of Figure 2.

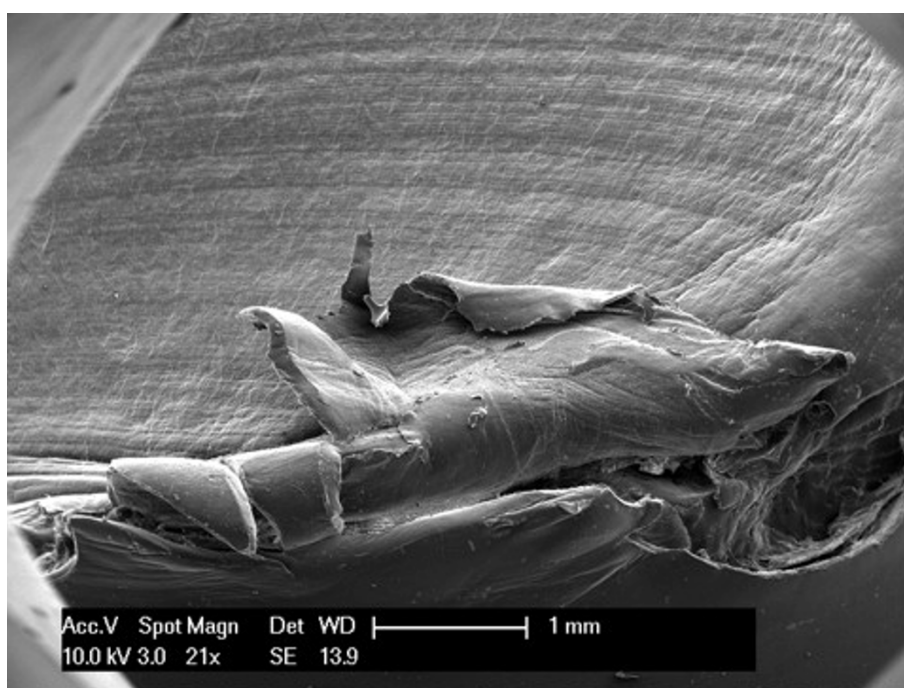
**Figure 9** Area 6 of Figure 2.

caused by a non-optimal ligamentous balancing during the first implant surgery. Our patient's knee probably developed progressive varus instability that slowly weakened the post, and then an anteroposterior stress finally broke the polyethylene.

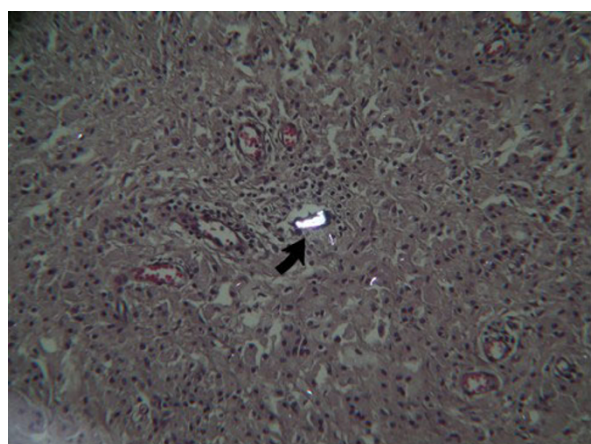
**Figure 10** Dense connective tissues with typical inflammatory cells and rare polyethylene flakes (arrow) are identifiable.

Light microscopy evaluation showed a typical chronic inflammatory reaction. Rare polyethylene flakes were identifiable under polarized light. These particles appeared to be well-controlled by giant cells. No metallosis was observed (Figure 10). Von Kossa staining returned negative results. Such findings can be considered normal sinovia in TKA. The absence of polyethylene particles confirmed the macroscopic evidence of the absence of wear, which could have caused the breakage.
