CASE REPORT

A simple new technique for the removal of fractured femoral stems: a case report

We present a case of fracture of a cementless long femoral stem, which is mainly used in tumor and revision surgery, and a useful technique to remove it from the intramedullary space of the femur.

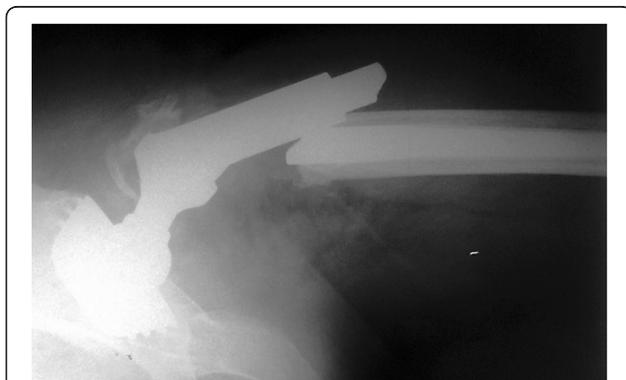
Our patient was given spinal anesthesia, in the lateral decubitus position. We used the direct lateral approach that was extended distally. The fracture was 7cm distally from the tip of the greater trochanter, just at the junction of the proximal and distal modular parts and at the level of the remaining bone after the primary resection (Figure 1). The proximal part of the femoral stem was extracted easily and without complications. We continued with the disengagement of the proximal portion of the distal part of the femoral stem from the surrounding bone. We needed at least 2cm to have enough space for two locking pliers. This was achieved with a longitudinal osteotomy through the anterior cortex extending distally for 10cm (Figure 2A). The transversal osteotomy was 2cm below the tip of the femoral stump to allow enough space for two locking pliers. The transversal osteotomy was about 60 to 70 percent of the total bone circumference as shown (Figure 2B). A lamina spreader was then inserted in the osteotomy line proximally and two bone

Figure 1 Plain radiograph of the fractured prosthesis.

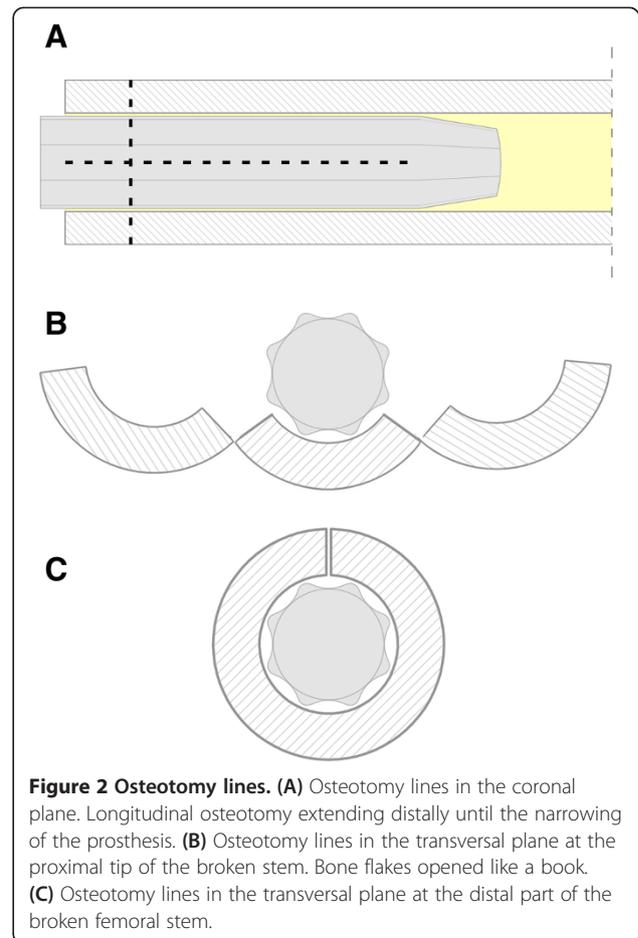
Figure 2 Osteotomy lines. (A) Osteotomy lines in the coronal plane. Longitudinal osteotomy extending distally until the narrowing of the prosthesis. (B) Osteotomy lines in the transversal plane at the proximal tip of the broken stem. Bone flakes opened like a book. (C) Osteotomy lines in the transversal plane at the distal part of the broken femoral stem.

flakes were opened like a book in order to provide space for the tip of the locking pliers (Figure 2B). The proximal tip of the broken stem was compressed as much as possible with two locking pliers. A lamina spreader was then inserted in the remaining distal longitudinal osteotomy and carefully opened for 1 to 2mm to allow the bone to separate from the stem, avoiding fracture of the femur (Figure 2C). Simultaneously, a hammer was used on the locking pliers and with several strong strokes the broken stem was removed from the bone easily (Figure 3). Next, a cerclage wire was inserted below the horizontal cut to prevent a possible uncontrolled fracture of the femoral bone during broaching. A second cerclage wire was inserted on the proximal 2cm of the femoral bone, which adapted perfectly. The femoral canal was reconstructed perfectly with minimal damage to the periosteum. The new revision prosthesis was then inserted in the standard manner (Figure 4).

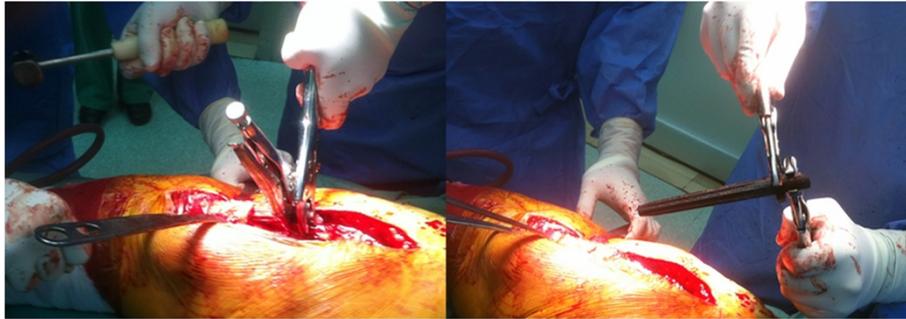
Figure 3 Intraoperative photographs.

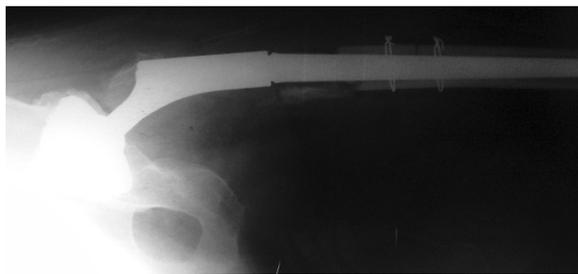
Figure 4 Postoperative plain radiograph. Note the excellent adaptation of the osteotomy lines.

excellent adaptation of the osteotomy line. Damage to the periosteum is only done during osteotomy through the anterior cortex and is minimized, which also promotes bone healing. Good fixation of the new revision prostheses can be made due to bone stock conservation and the excellent adaptation of the osteotomy line. This enables early mobilization and rehabilitation of the patient, minimizing the postoperative complications.
